Safety Alert

A47 Guyhirn Junction water supply damage

27 April 2021

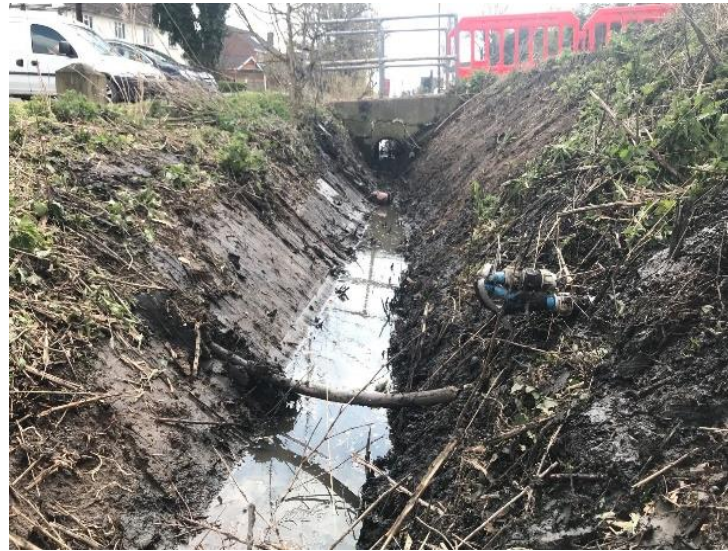
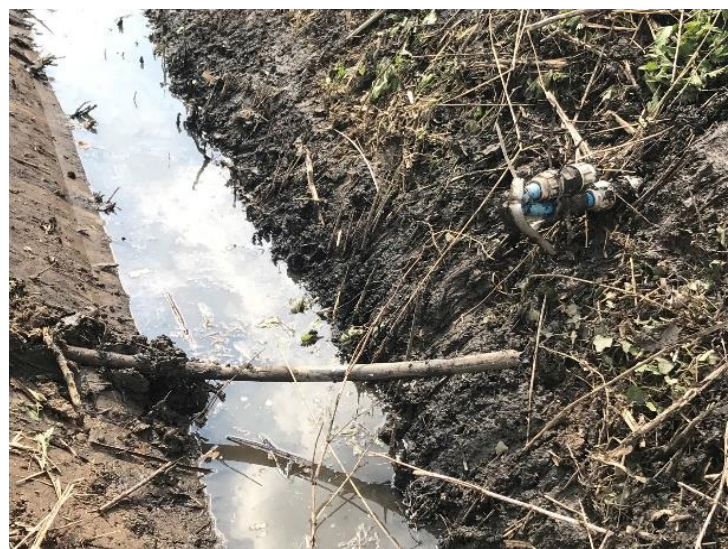
As part of planned site clearance works for the A47 Guyhirn Junction Scheme, a ditch on the edge of the scheme boundary was being cleared using an 8t 360 excavator, with ditching bucket attachment. During the works, an uncharted 25mm black HDPE pipe (high-density polyethylene) private water supply service was damaged. The water supply serviced 4 nearby bungalows built in the 1970s. Anglian Water were alerted and attended site promptly. The repair was fully completed the same afternoon.

- A permit had been issued for the works. The water supply was not charted on any utility drawings and was unable to be picked up when the area had been scanned using service avoidance equipment prior to commencement. The utility was also not picked up by the ground penetrating radar, as the ditch was outside the main construction area.
- The utility pipe was sitting within the silt deposits above the ditch invert level and was not visible prior to excavation. Because the colour of the HDPE (high-density polyethylene) pipe was black instead of blue as standard, this made it even more invisible to identify.
- The repairing Anglian Water Engineer acknowledged that this utility was not laid in accordance with current standards.
- Anglian water is investigating the legality and ownership of this utility.
