# Safety Alert

## Water main release - thrust block

3 September 2020

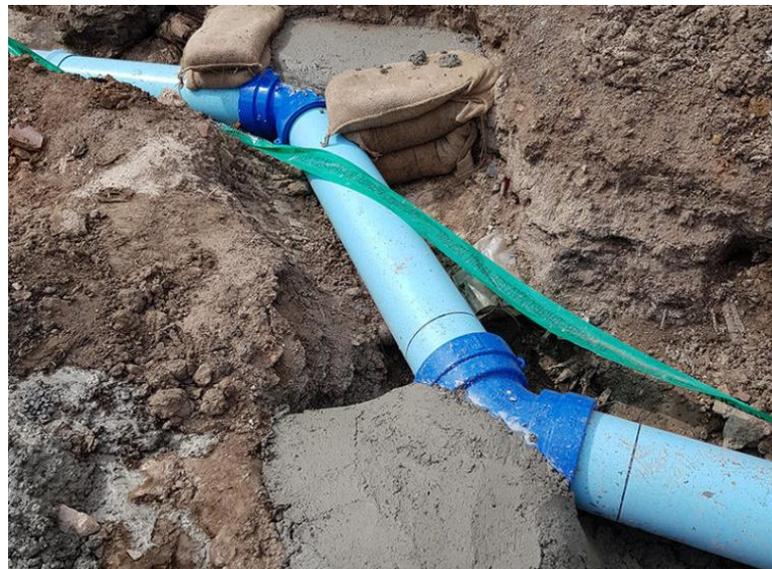
- During these works the concrete obstruction (now identified as a thrust block) was dislodged. This led to the water main in the vicinity coming away and the site flooding.

Above: Typical example of thrust block in situ.

- Position of the water main adjacent to the concrete had been determined from other known points (from trial holes) on the water main. The actual position should have been clarified once the block of concrete had been uncovered
- Assumptions were made that the concrete was waste from other construction work – we should never assume and this ties back to point 1 above
- Key learning – failure to STOP when change occurs. The full situation should have been assessed, advice sought as required from the site supervisory team, the work pack amended with the new way of working and working practice briefed.
