High Pressure Gas Main Strike

Failure to Manage Data led to High Potential Near Miss

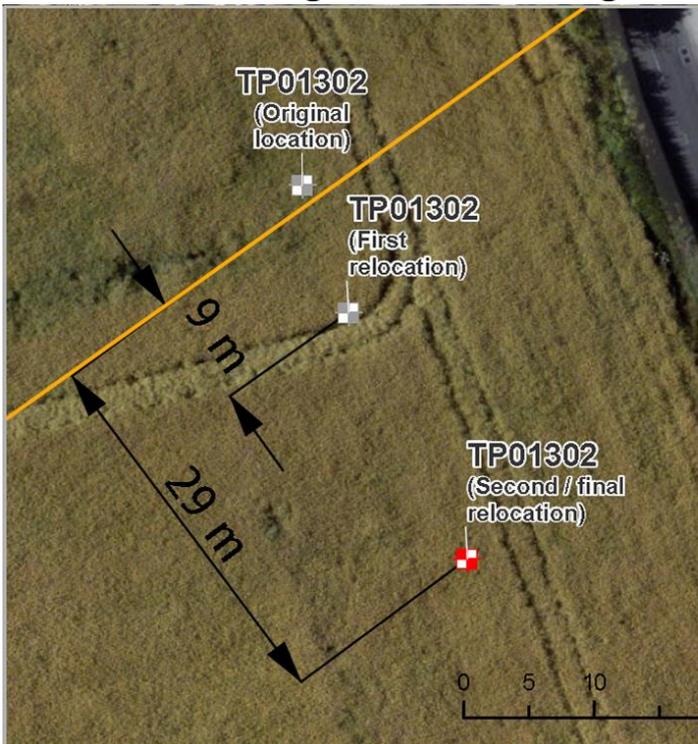
The sub-contractor set out the location of TP01302 using a digital GPS device, however the data within this device had not been updated since May 2020 and as a result TP01302 was set out in its original location, directly over the high-pressure gas main. The engineer also failed to check the information within

Following procedure, the area around the works area is required to be checked for signs of furniture which could suggest the presence of services and a CAT & Genny scan of the works area undertaken. Both requirements were not completed to a suitable standard, missing the opportunity to identify a high-pressure gas marker board 10m away or the 500mm cast iron service below the position.

At 3m the excavator operator felt unusual resistance as a 50mm scrape of the excavation was being undertaken. On inspection, the high-pressure gas pipe was identified. All works were immediately stopped and the emergency plan followed calling to site the service provider.

While the root cause of this incident is a failure of the non-AECOM design team to eliminate the risk through design. The poor management of data within digital devices was a significant underlying cause.

1. Ensure that the change management system seeks conformation of changes and updates to digital data sources and storage.
2. Storage of setting out data within digital devices should be kept to an absolute minimum, with data being inputted to the device within 24hrs of its use.
3. Prior to any setting out being undertaken from stored data within a GPS device, the coordinates within the device are to be checked against those within the permit to work / work authorisation pack.
4. A photo should be taken of the GPS device screen displaying the location coordinates, matching those on the permit and attached to the permit prior to final permit approval to instruct breaking ground.
5. The numbering convention for relocated trial pits and boreholes should ensure that when any proposed or commenced location is moved, it is issued with a new trial pit / borehole number.
