PREVENT SERVICE DAMAGE

32mm Gas Service Damage

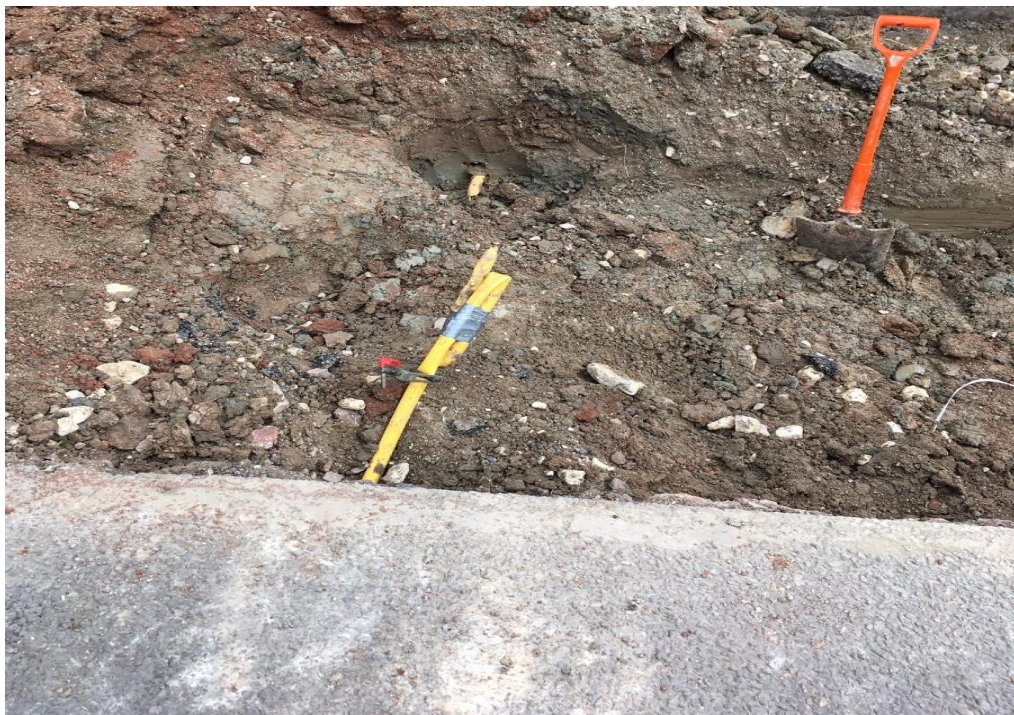
During the mechanical trench excavation works several weeks later a 32mm PE gas service sustained damage . This was located approximately 30 metres from the area shown on the drawings and was running at a 90° angle towards the kerb.

There were no visible signs that a service was located in that area and no building close by . It was observed following the damage that the service did not have a fine fill material or marker tape cover.

1. Always use utility drawings as guide only
2. If an assumed utility is not located during trial holes consider the following –
 - a) Additional trial holes
 - b) Use of GPR
 - c) Services usually run at 90° angles from the main
 - d) Report details to the asset owner for guidance

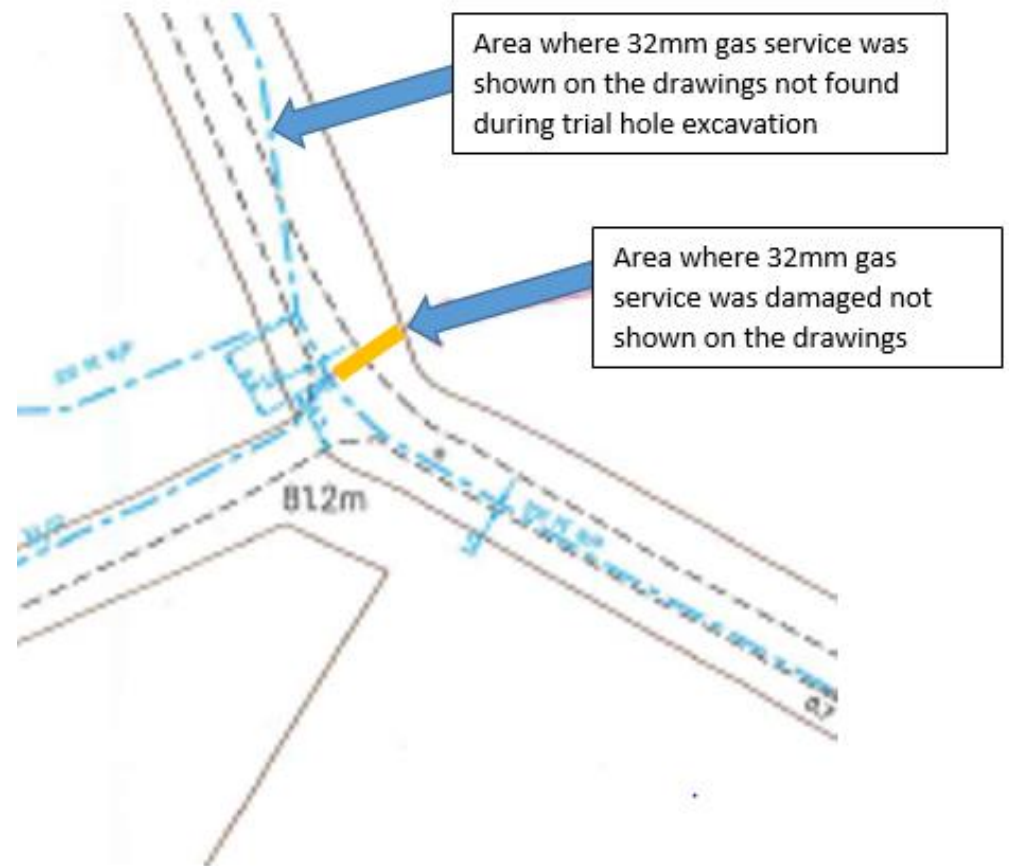
Controls in place consisted of a risk assessment, POWRA, desk top survey, trial holes, permit to dig, banksman and use of a CAT4 & genny prior to and through out the dig
