What Happened?

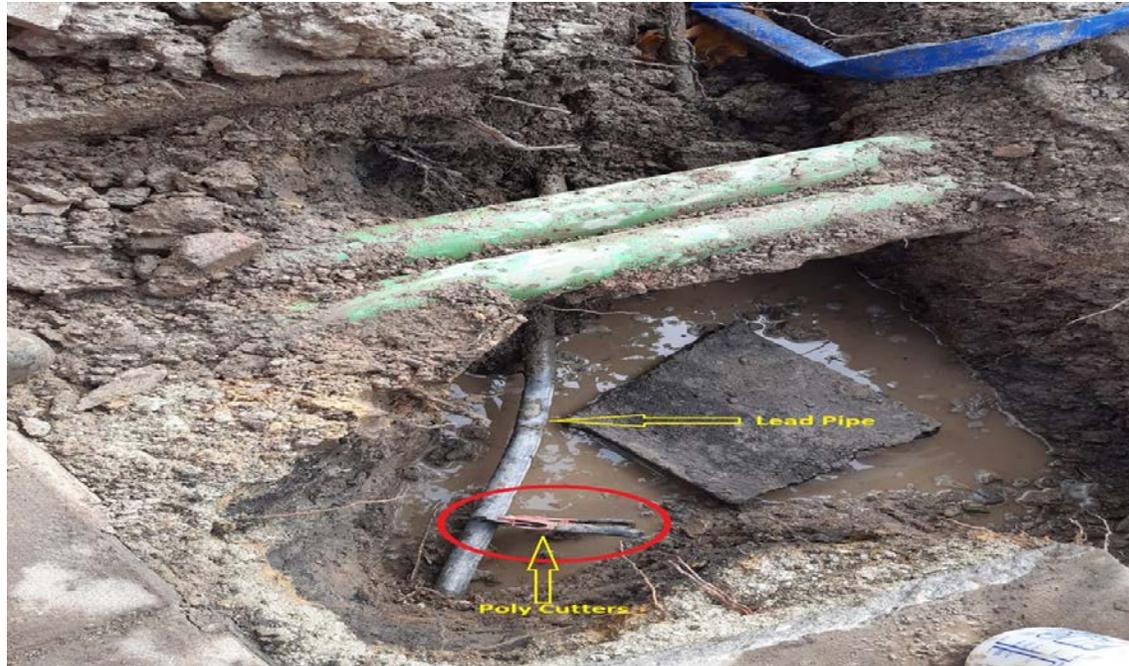
- Team were tasked with undertaking a service pipe relay in the carriageway which ran to the boundary of the property.
- Team had successfully excavated in the footpath, exposed the 4" main and partially dug the relay trench in the carriageway. They had located and positively identified a lead water supply in the carriageway.
- As the team leader started cutting the lead pipe located in the footway with a pair of poly-cutters, there was a pop and a puff of black smoke.
- There were no injuries to either team member on site.

- During 3 days of work, the team had a number of setbacks causing the delay, one of which was a failed ferrule on the main resulting in the trench being filled with water.
- Team Leader made assumptions that the lead pipe he cut must be the water supply as it was in line with the lead supply he had exposed in the carriageway some 5m away.
- Team leader did not undertake any checks to positively identify the service as water:
- Failure to undertake specified checks to positively identify service
- Failure to call supervisor before cutting into service as briefed 2 weeks previous despite various changes to the original job there was no stop point and site meeting held to discuss the changes and replan the job.

- Always follow Safe digging procedures, they are designed to protect you, your peers and members of the public (RAMS, HSG47, site specific procedure).
- Reassess the area to be excavated and escalate any findings to supervisor when unsafe conditions are observed.
- All identified services should be clearly marked up, extended outside the work area and in the excavation. Renew mark up if top layer has been removed.
- Follow the safety critical checks process before cutting into a main, service or duct.
- If in doubt STOP!
