What Happened

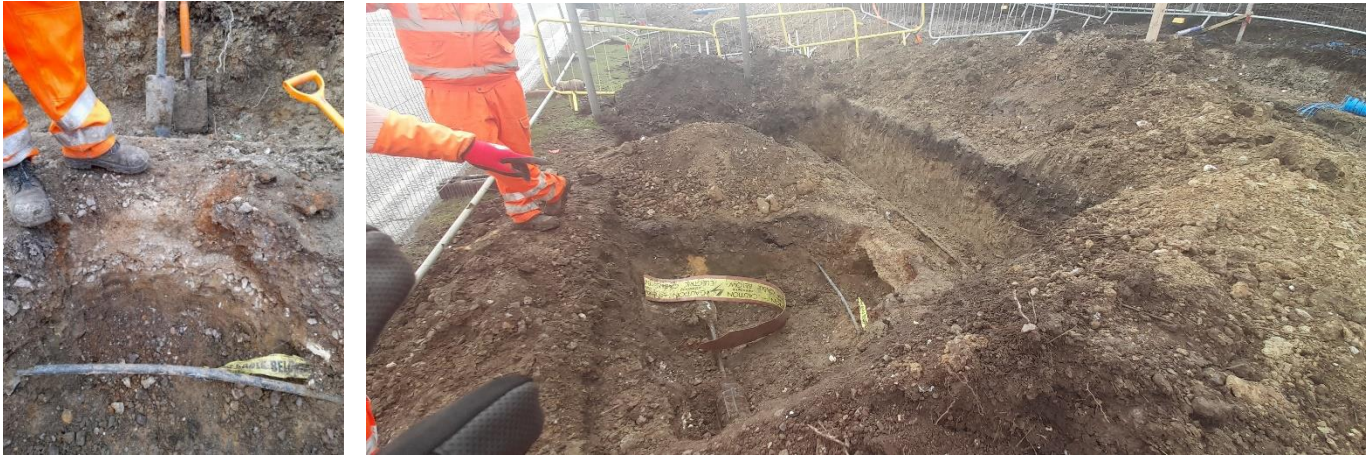
Whilst undertaking trial holes to enable UKPN to make connections of two known power cables in the area, an operative using insulated hand tools came into contact with a low voltage street lighting cable, damaging the outer sheath of the cable.

No one was injured in the incident, the operatives were wearing full flame retardant PPE and there was no arcing, sparks or smoke. The cable was not energised at the time of the damage, there was no loss of power and the streetlights were operational in the evening.

- Ground penetrating radar drawings had identified the presence of the cable, but these had not been provided to the excavation gang with the Permit.
- A Vacuum Excavator couldn't be used due to restricted access and traffic management conflicts.
- The Genny was not used to accurately identify the street lighting cable (which wasn't energised).
- Air picks/lances were not considered or used as part of the safe system of work.
- Competency of the appointed persons for issuing permits and service location on the ground had not been confirmed.

- Ensure the relevant drawings are provided and available prior to approving permits
- Ensure that Appointed Persons competency checks are reviewed and confirmed as part of the appointment process.
- Follow the hierarchy of control - and wherever practicable, use vacuum excavation and/or air lances in proximity to services
- Make regular, frequent sweeps of the CAT scanner, always utilising the Genny
- Stop work if anything changes. Consult management and key personnel before continuing.
