# HEALTH AND SAFETY BULLETIN

## Tilbury Douglas— Electrical Service Strike

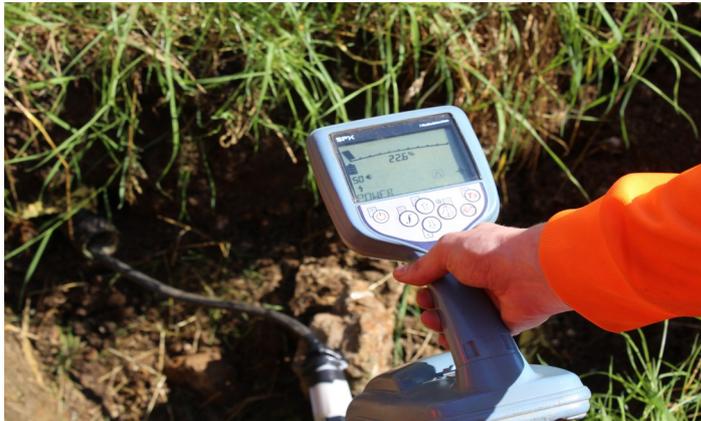
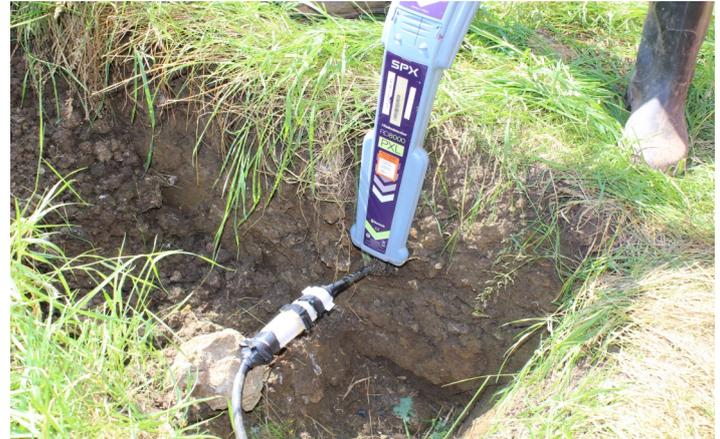
The overarching failure to detect the service was that service avoidance and detection scans were performed with the sensitivity of the equipment reduced owing to interference from a metal chain link fence and buried metal posts which were in close proximity.

The interference from this fence resulted in the sensitivity of the detection equipment being reduced to such an extent that the service was only detectable when within 50mm of it.

The service was buried at a depth between 250-350mm and although the excavation was rechecked at the first cut of 150mm the cable was outside of the detection window and was struck when the next 150mm was removed.

A further contributory factor was that the service was contained within a duct, running to a pump which the Genny could have been clamped to and signal generation would have detected this service (this was achieved at incident reconstruction), but was missed as vegetative growth had obscured it.

**Pictures show:** ZERO detection at 50mm above the energised service (post repair).

**Action:** Ensure a full visual inspection of the work area and its immediate surroundings occurs. High vegetative growth means you cannot do this so is a **STOP POINT** until it is safely reduced (Strim down with a nylon corded strimmer not a metal blade cutter).

**Action:** If significant interference is encountered whilst attempting to use service detection and service avoidance tools this is a **STOP POINT** and contact should be made with your Regional Health and Safety Advisor.
