Surface Cable Damage

- Electrical cable snagged by reform mower during grass cutting operation, 16 April 2020 at the Barley Mow junction A43/A421
 - Electrical asset knockdown in same location on 28 June 2017 – made safe at that time (isolating and marking the location with a traffic cone)
 - Multiple grass cutting visits between June 2017 and April 2020 – no reported issues
 - A walkover on this occasion was undertaken and this is the same for all cuts – the cable was not observed, but sign frames were discovered and removed from site

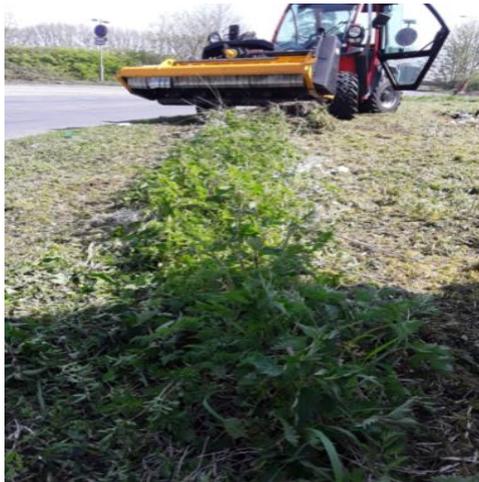
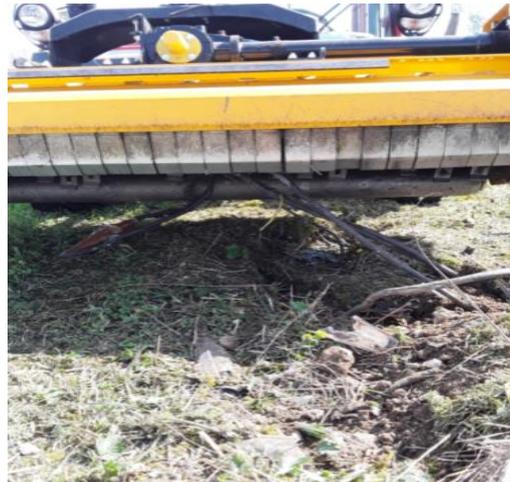
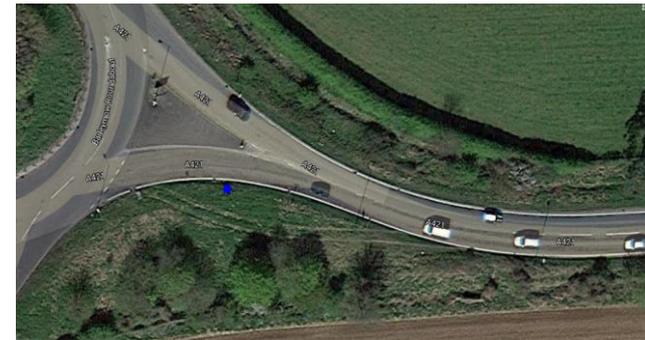
Immediate Cause	Operators did not see any obstruction Cable was within the cut height of the mower
Underlying Causes	The cone used to mark the cable had been removed / damaged The passage of time between the knockdown and the incident may have permitted the cable to deviate from initial position, to be at a higher elevation
Root Causes	A cable was left on the surface where it could be compromised by grass cutting operations Standard operating practices at the time permitted an insecure method of highlighting the cable, albeit they did include the practice of electrically isolating the cable from the supply The grass cutting team were not advised of the potential of a cable No immediate permanent repair scheduled on the back of the temporary 'make safe' visit
