Best Practice in Avoiding Underground Services

Services encased or surrounded by concrete

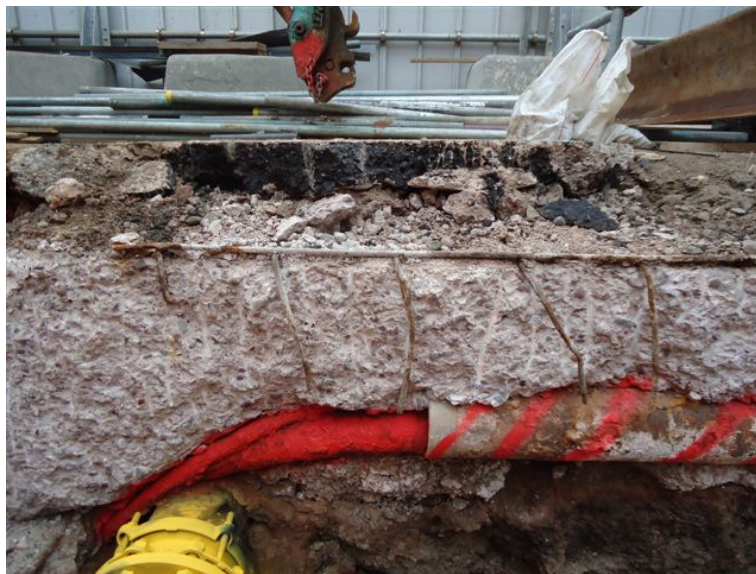
The following decision map / flow chart describes a simple way to manage the discovery of services encased in or surrounded by concrete.

This is primarily aimed at site supervisors, team leaders and site managers, but is also applicable to designers / planners.

The principle that when any service is discovered to be encased or surrounded by concrete **work must stop**, to establish the reason for the concrete being present. Ideally a **diversion** or (if that is not reasonably practicable) **isolation** of the services should be adopted. This “decision map” / “Flow-chart” should be used, which is equally applicable at design (survey) stage as it is in construction or maintenance stages.
