## SAFETY ALERT

## Learning From Incidents

Injury Type:	Service Strike	Date:	09/07/2019
--------------	----------------	-------	------------

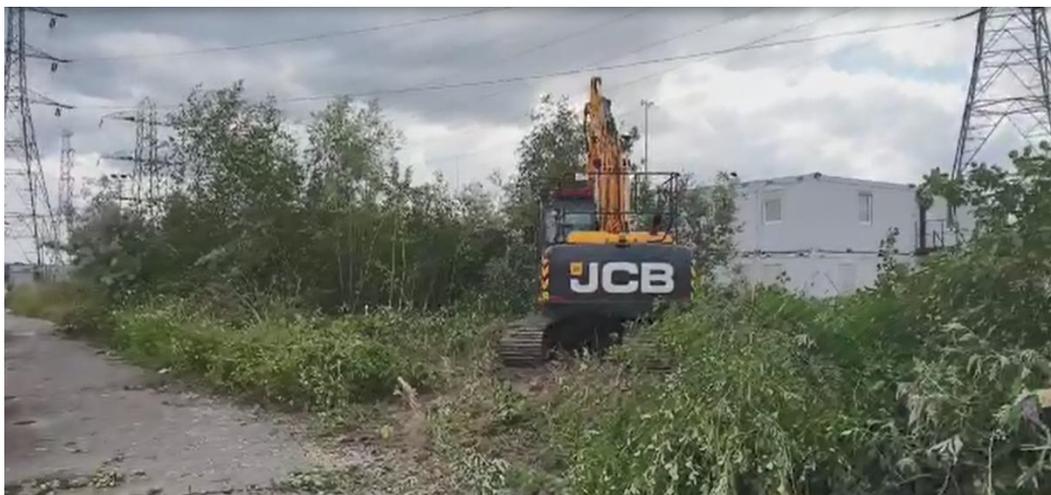
On the 2<sup>nd</sup> July, at approximately 15:35, a service strike occurred when an excavator tracked over an above ground 415V armoured cable. This cable was located in the vegetation clearance area of the satellite compound in Ingrebourne Valley. The excavator (with a grab attachment) was completing vegetation clearance works for site compound set up.

The service strike caused immediate loss of power to the neighbouring site welfare cabins of Brown and Mason. Following the strike the excavator operator stayed in the cab and called for assistance. Brown and Mason representative and their electrician were called to the scene and confirmed power had been lost and the area made safe. The excavator driver was then able to track back to safety and stand down.

The power was supplied by a generator situated in the work area of Package B. Perfect Circle and Socotec Site Management believed the area was free from services. They had received a guidance certification from the site owners which was misunderstood and heavily relied on. The certificate also failed to mention the power generator.

Failure to follow PAS 128 correctly, before any works commenced. They did not look at their surroundings and investigate any furniture which could have utility supplies, in this case the generator and cabins.

Had this been undertaken the direction of the over ground cable could have been identified, prompting further careful investigation prior to the works being undertaken.

Too much reliance was placed on service plans and client certification of services. These documents must be treated as guidance only. All services **must be** identified and traced on all packages.

Appropriate site planning would have identified the generator and cables as a hazard for the works. Works should **not** have commenced in the area of the generator until cable direction and status (live / terminated) was clarified.
