Positive Interventions

Cable Encased in Concrete

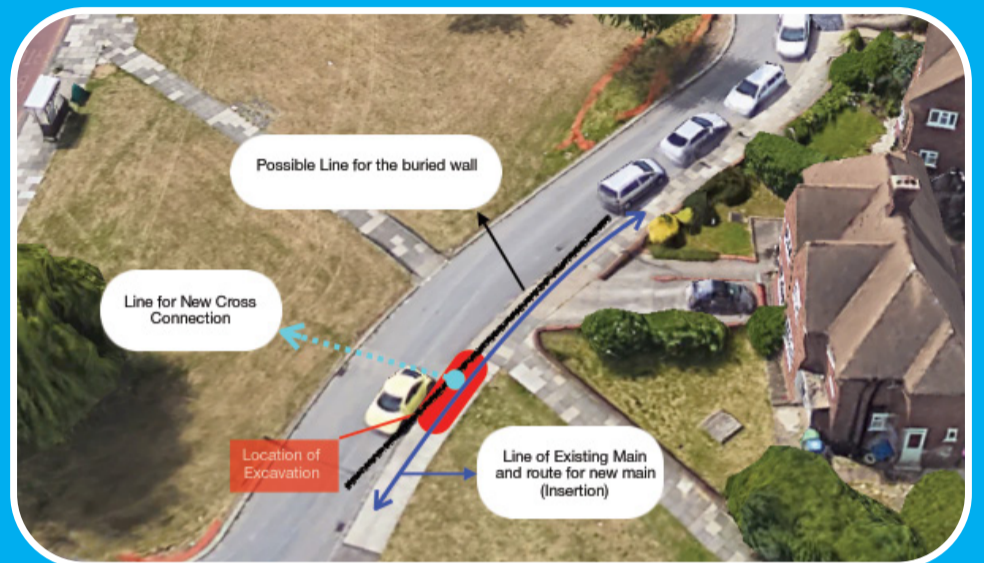
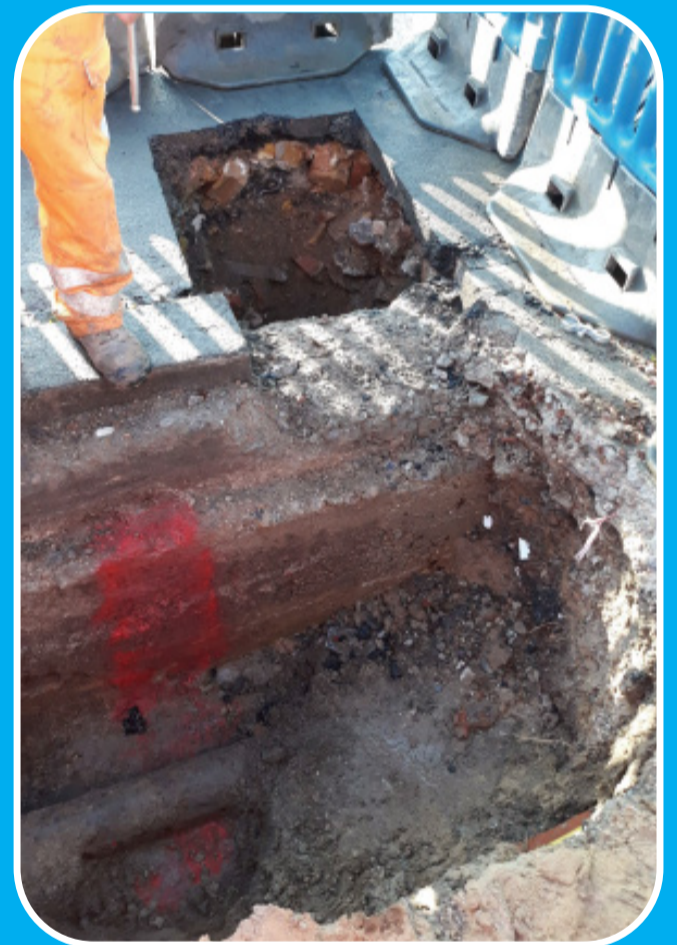
The BLU-3 team were excavating at Partridge Green for a new cross connection. While scanning the ground they received a strong signal from the CAT indicating a cable, either encased or underneath a concrete wall in the ground. There was insufficient cover to bring the new main over the wall and it is not possible to go under the wall due to the risk of the suspected cable.

The route for the cross connection is to be changed. Trail Holes further down the line are to be dug to see if the buried wall persists. The design is to be revised to facilitate the unknown buried wall.
