Cadent Gas Repair  
(LTI Potential +7 day RIDDOR Reportable Incident)

# London Repair West – Lost Time Injury

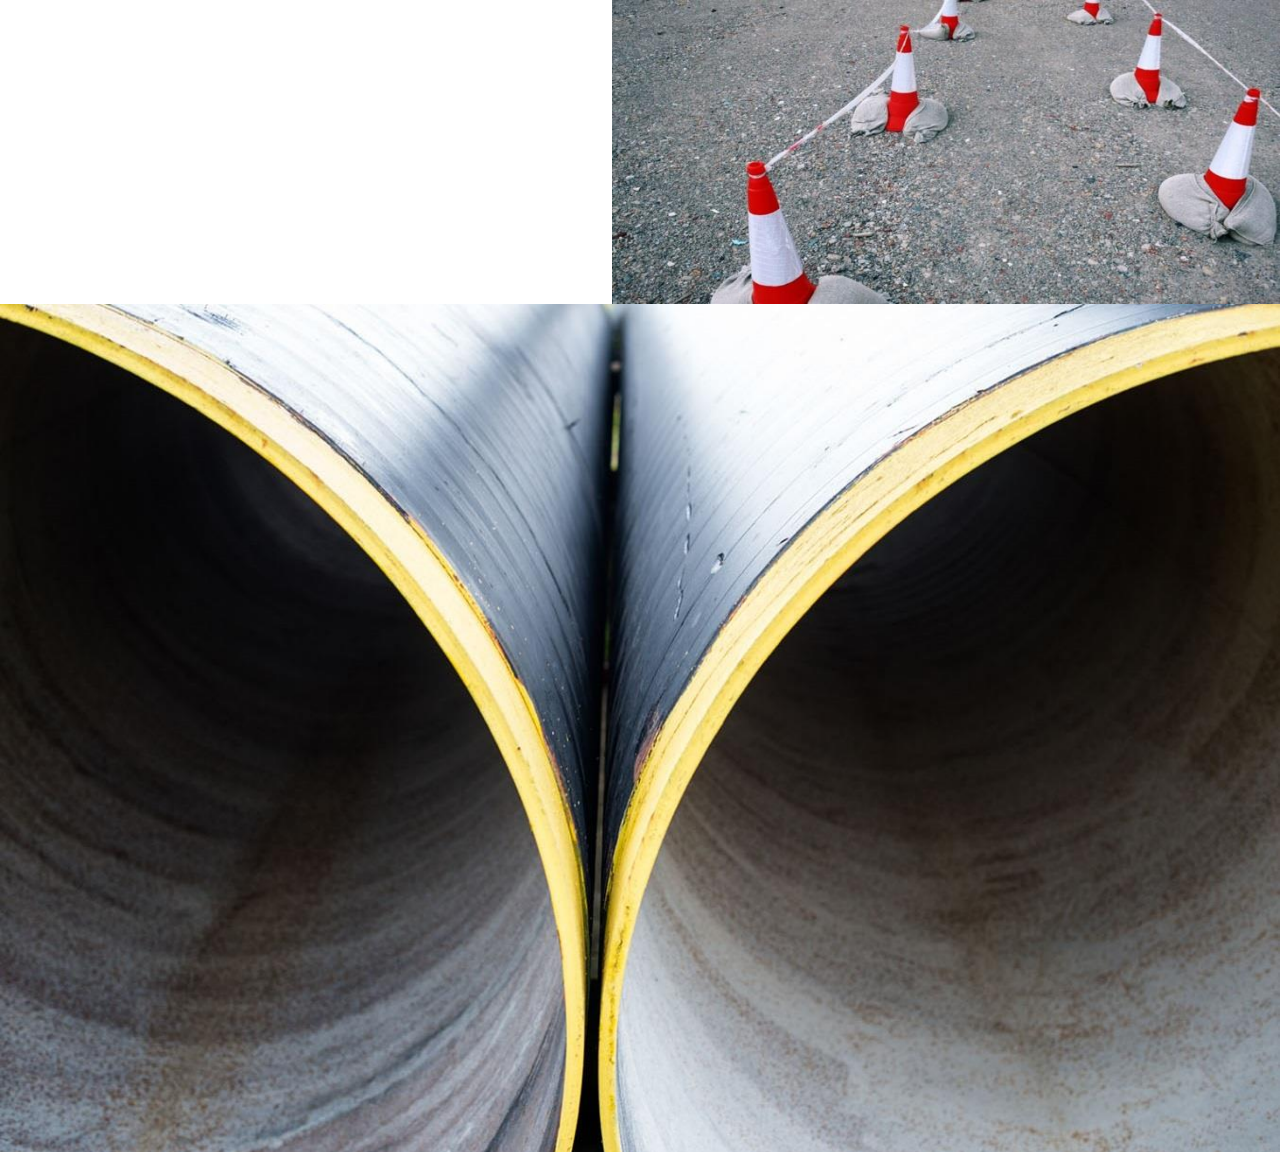
The team attended site to find and fix a public reported gas escape. Their gas mains diagrams showed a LP gas main located in the footpath where their OSGEM checks indicated the highest reading to be and a MP main in the road verge. Their cable plans identified that a 11kVA HV cable plus six LV cables were located in the footpath. A manhole cover, which they had lifted identified BT cables also in the footpath and on the presumed line of the LP main.

As they excavated gas reading dropped away. Testing the perimeter of the excavation trace readings were found on the edge of the excavation nearest the marked location of a HV cable. Their gas detector faulted due to rain water clogging the cotton filter. The NCO1 mate changed the filter while the team leader went back to the van to order extra barriers. The NCO1 removed his leather gloves and changed the cotton filter. The NCO1 then decided that he would try and obtain better readings by using the Horizontal Searcher Bar. The NCO1 was aware of the HV cable proximity to the edge of the excavation but presumed he had enough space. He had not replaced his gloves. As he pushed the Horizontal Searcher Bar into the side of the excavation, using hand force and bare hands. The Horizontal Searcher Bar came into contact with the HV cable which failed in an explosive flash.

NCO1 injuries - 2nd degree burns to his hands – minor skin injury to skin below left eye brow – minor burn injury to outer edge of left ear – ‘sunburn’ type injury to skin over left side of face.

- Re-brief all Repair employees on H1.2 requirements and register training + Set up process to brief all new Repair employees on H1.2
- Audit compliance with H1.2
- Amend PPE requirement and for work near HV cables so that Flash Hoods and visors are required when HV cable are exposed or excavation is within 500mm of known/presumed position of HV cable
- Amend HV cable check sheet and H1.2 to include upgrade of PPE (flash hood & visor – consider use of fire suit as well)
- Brief all Repair employees & Supervisors on required use of HV cable check sheet – note there is a CAG proposal for this check sheet to be made a mandatory stand alone risk assessment form as addendum to the Take Care sheet, it is recommended this is adopted.
- Recommend Appreciation/Award to Team Leader and mate from Assisting team in recognition of their prompt support and actions.

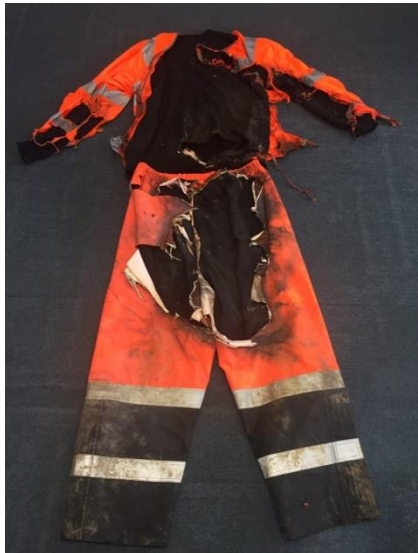
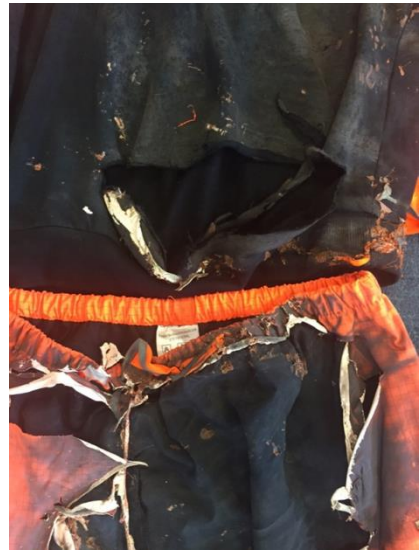
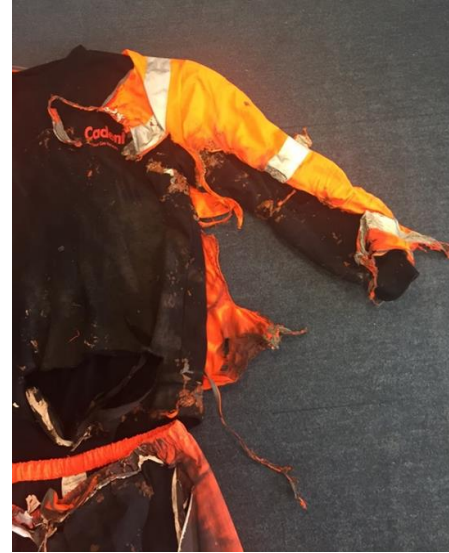
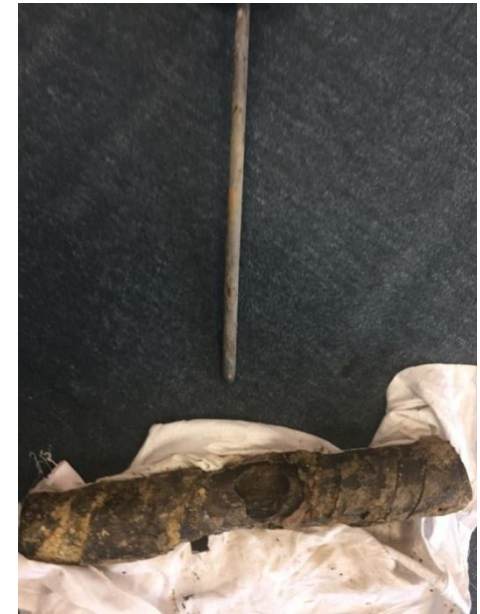
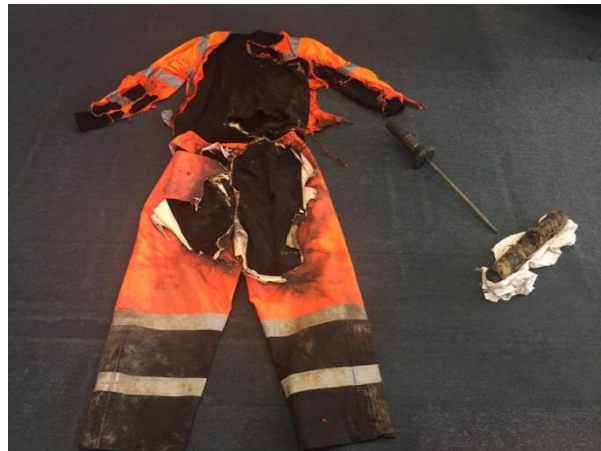
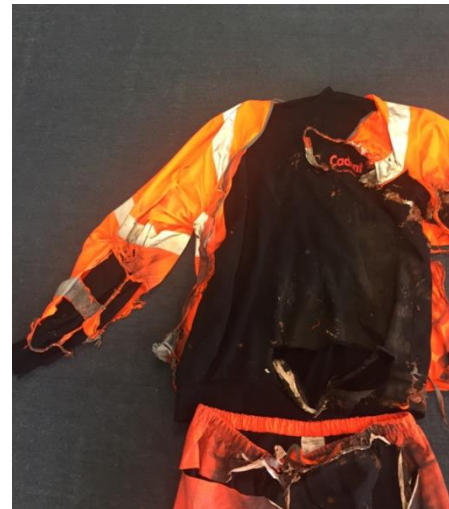
# London Repair West – Lost Time Injury

- **T/PR/TE/H1.2 requires that use of the HSB shall only be carried out on the line of an exposed main at the 3 & 9 o'clock positions**
- **When hand digging within 500 mm of HV cables, air knife/air pick, spades and shovels should be used. Picks, forks and pins shall not be used.**
- **Bars may only be used as a lever to loosen large stones.**
- **Goggles were not used by NCO1** - The NCO1 was wearing safety glasses. He had a minor injury to the skin under his left eye brow
- **The NCO1 had removed his gloves and had not put them back on before using the HSB**
- **The NCO1 was not wearing overalls** – he had no overalls available – he had not received a mobilisation pack – **FR clothing he was wearing protected body.**
