Follow Up Incident Notification – Lessons Learned

Project/Location: McDonalds Restaurant, Mullingar, Co. Westmeath
Client: Gas Networks Ireland
Incident Date: 24-03-2019

Incident Type: Service Strike
Incident Classification: HiPo
iSMS Reference: 652047

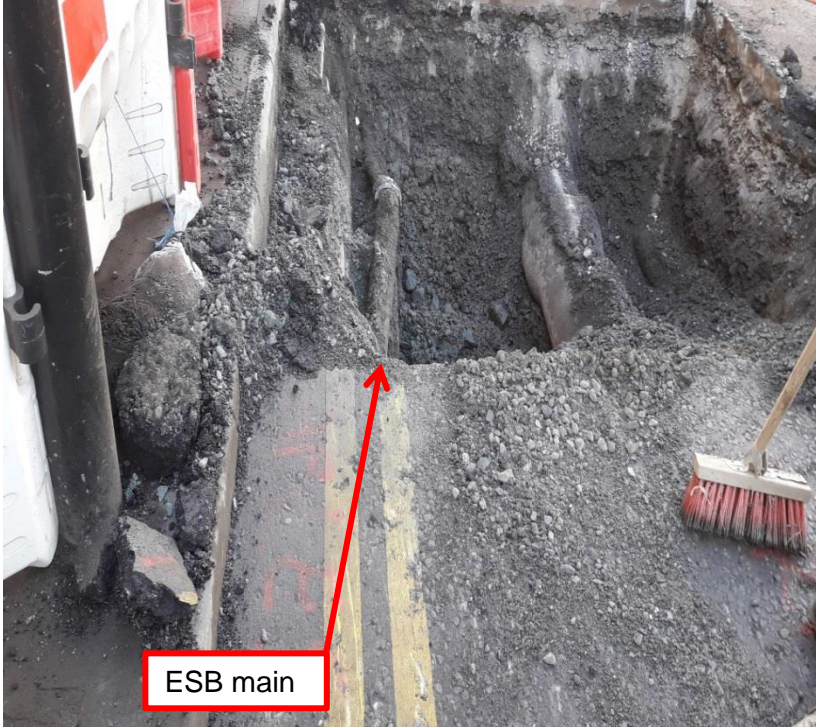
Incident Description	Incident Type	Incident Owner
<p>During planned weekend work a 10 kV medium voltage (MV) cable was struck by an excavator.</p> <p>A subcontractor/DLO blended team were tasked with extending the existing gas main at a depth of approximately 1.7m.</p> <p>Temporary works designs were authorised and planned for the job.</p> <p>Service plans were provided in the job pack and indicated the presence of a 10 kV/20 kV MV cable.</p> <p>Cable was traced, located and marked.</p> <p>Despite knowing the presence of existing services, the team allowed the excavator to work within 500mm of the various utilities.</p> <p>The cable was struck by a combination of the bucket of the excavator and material shift towards the ESB cable at a depth of approximately 400mm.</p>	10 kV electrical strike	John Dunne – Delivery Manager Cells 1 & 2 (PE Distribution)

- Breach of the Code of Practice as plant was operating within 500 mm of known or suspected services.
- No protection placed over the pipe once exposed which could have provided visual and physical control.
- Safe hand digging practices including use of the soil pick were not used in this location.
- Marking of utilities was completed but has room for improvement (see photo).

- Work stopped and ESB were contacted.
- ESB came on site to complete 'make safe' temporary repairs and then completed full repair.

1. Significant Incident Review to be held week ending 07.06.19 with relevant personnel involved, PE Operations Manager, HSEQ Manager and Head of Contract. Just Culture model.
2. This Lessons Learned document to be cascaded to all relevant operational personnel with briefing register signed as read and understood by all.
3. All contracts should ensure that all employees have undertaken an operationally lead, Making Safety Personal (MSP) 1 session.
