Safety Alert

Water Service Strike

4 May 2021

HEi234

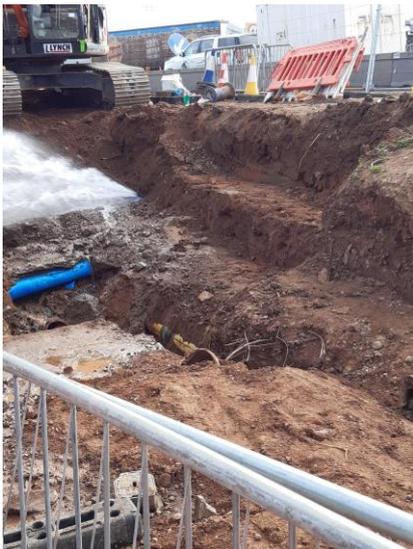
Damaged pipe releasing water

At approximately 08:15 on Friday 16th April 2021 a 300mm dia watermain was struck by an Osborne supplier's 20t 360 excavator. This occurred while undertaking operations to install a new drainage run and chamber location. It caused damage to the pipe and a significant water release.

1. Ensure all services are exposed (Trial Holes) in dig area.
2. Ensure those involved in task are adequately briefed and fully understand service locations, permit constraints and safe digging practices required.
3. Plan works effectively to ensure maximum use of safe digging techniques (Vacuum Excavation in this case) to identify all services and minimise mechanical excavation.
4. Ensure daily permit checks are undertaken.
5. Ensure all personnel on site feel empowered to STOP works, challenge and raise concerns higher if response does not allow works to proceed safely.

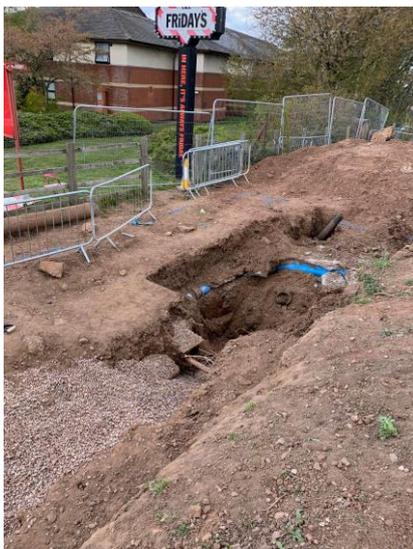
Previous Vacuum Excavation works undertaken to expose chamber location (Old watermain shown)

Vacuum excavation had previously been undertaken to expose services around the new drainage chamber location, but this did not expose the subsequently damaged watermain location. The services were marked on the ground, a trial hole had been undertaken previously adjacent to existing drainage run (which new drainage run would follow) to identify watermain location.
