**SP ENERGY
NETWORKS**

Case Study: Electric service cable found inside gas pipe (ducting)

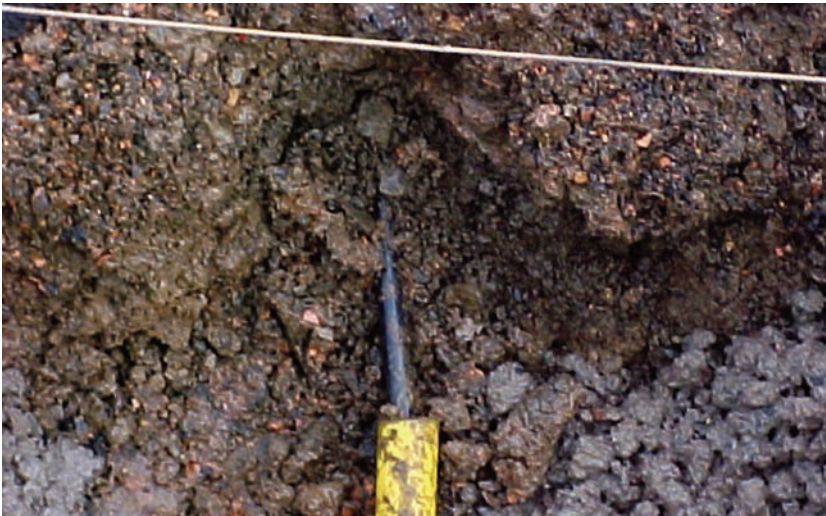
The above image is an example of poor working practice, a gas pipe being used as a duct for an electricity service cable.

This type of situation can result in operatives being injured due to the incorrect ducting being installed. National Joint Utilities Group (NJUG) recommendations include a colour coding scheme primarily aimed at creating a safer environment for all operators. It is also intended to reduce the cost of damage caused to other plant and to optimise safety of individuals.

Prior to any excavations taking place cable records should always be consulted.

It is dangerous to use designated ducting for the wrong application. It is recommended that you never adopt this poor working practice.
